# Belgoprocess

## Decontamination and decommissioning of a 2,000 m<sup>3</sup> open storage pond for liquid waste and sludges

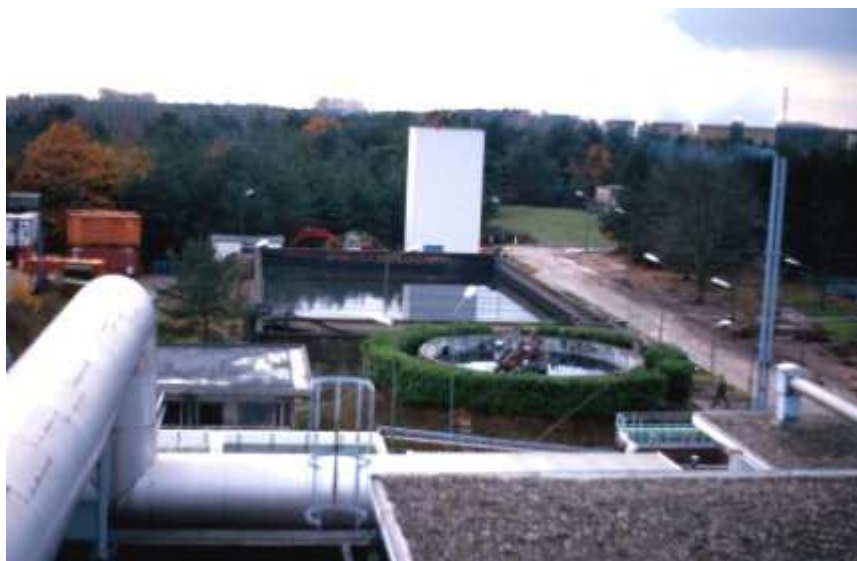
Figure 1. Open storage pond in original status

The 2,000 m<sup>3</sup> open storage pond on the Belgoprocess site 2, the site of the former waste treatment department from the Belgian Nuclear Research Centre was constructed in the years 1957-1959. It is a large rectangular reservoir of about 42 m long, 20.5 m wide (external dimensions) and 3.5 m high (internal dimension) (see Fig. 1). It has in fact two parts, one with a volume of 200 m<sup>3</sup>, the other has a volume of 2,000 m<sup>3</sup>. The outer walls of pre-stressed concrete have a thickness of 20 to 33 cm. The floor of the 2,000 m<sup>3</sup> part has two layers of 10 cm thick concrete plates. The joints between the various concrete plates have been filled with bitumen. The second layer of concrete plates is isolated from the first one by means of a bitumen layer and two small layers of sand and concrete. The 200 m<sup>3</sup> part has a one piece 33 cm thick floor plate.

At the inner side of the concrete walls of the 2,000 m<sup>3</sup> part, a 20 cm thick brick wall was erected and the area between the inner wall and the outer pre-stressed concrete was filled with a bitumen layer. The entire inner

Three sides of the entire open storage pond were supported by 1.5 to 2 m high and 4 to 6 m wide sand shoulders that reached up to about 1.5 m from the top of the side walls. Only the northern wall had no sand shoulder.

On top of the open storage pond an aluminium roller-bridge was installed with 300 kg lifting capacity. It covered the entire width of the reservoir.

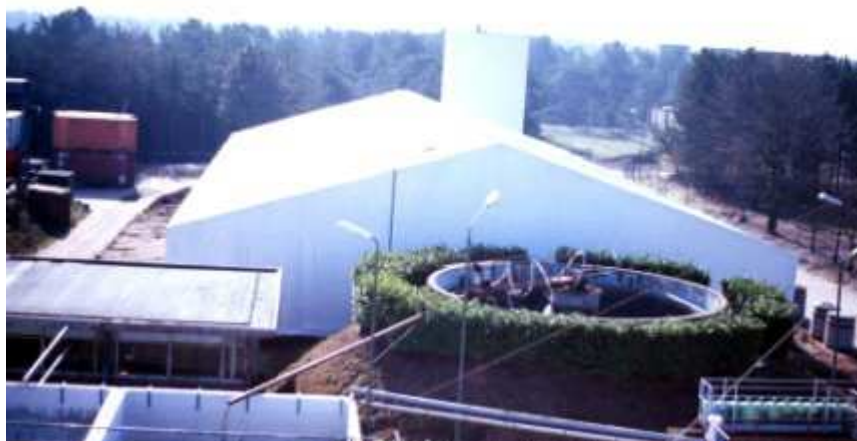
Figure 2. Open storage pond covered with tent construction

When the decision was taken in 1991 to shutdown the incinerator, it was also decided to empty the 2,000 m<sup>3</sup> pond and to prepare the decommissioning activities. For this reason, the pond was covered with a tent construction, i.e., a metal framework spanned with a canvas, and all supply and discharge pipes were disconnected (see Fig. 2 above). Two ventilation groups with pre-filters and absolute filters were installed on both the eastern and the western sides of the pond in order to provide acceptable ventilation and protection of the environment during all future treatment and decommissioning activities.

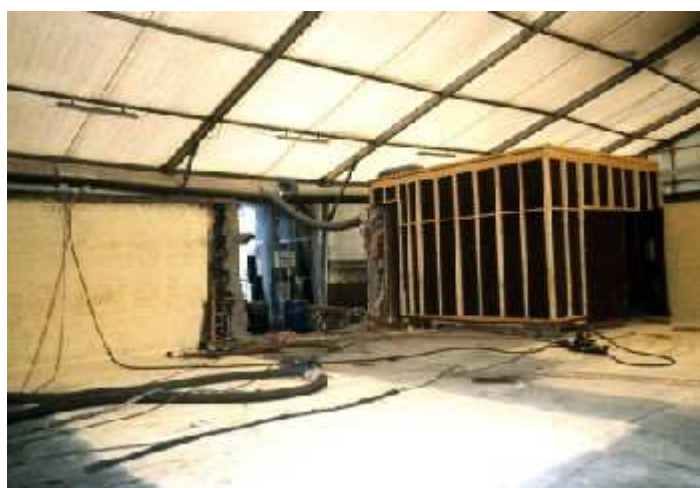
Figure 3. Organisation of decommissioning areas

As a result, two mobile intervention areas were constructed (5 m x 5 m x 3.75 m) in which the decommissioning activities could be organised and which could be moved along the inner wall depending on the progress of work (see Fig. 3). As such, in practice two mobile cell structures were developed, both having their own ventilation system, which should be independent from the main ventilation of the tent construction.

Following the removal of all equipment, the decontamination and removal of the inner brick walls of the 2,000 m<sup>3</sup> pond could be started. In a first of the two mobile intervention areas, an adapted milling cutter fit on a conventional fork-lift truck, was used as a very effective semi-automatic tool to remove about 1 cm from the wall surfaces. The radium contaminated dust was collected in special 200 l-drums and removed.

After the removal of this surface layer, additional samples were taken from the remaining part of the brick walls in order to confirm that this part was free of radium contamination. As a result, the second mobile intervention area was used to remove the remaining brick structure, which was cut by means of a conventional electro-hydraulic hammering unit. The material was evacuated in 200 l-drums as standard beta-gamma waste.

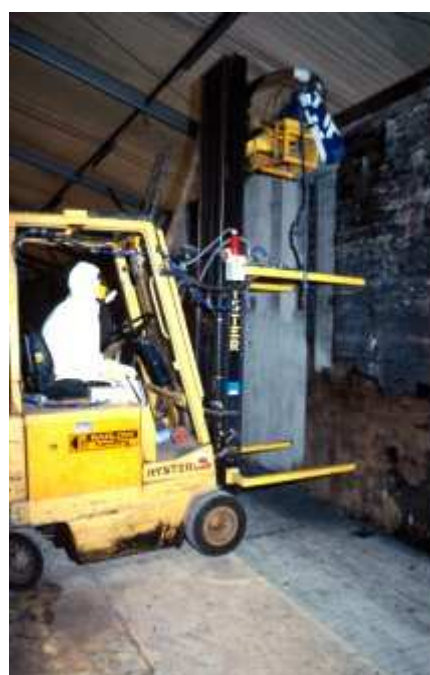
Figure 4. Removal of bitumen layer

As a next step, the bitumen layer between the inner brick walls and the outer pre-stressed concrete walls of the 2,000 m<sup>3</sup> pond was removed (see Fig. 4). An adapted milling cutter was used which was fit to the same fork-lift truck, giving effective results similar as to the removal of the brick layer. A thin layer of concrete was removed as well from the inner part of the outer walls in order to remove any remaining activity.
